**AQUAPHALT®**  
the permanent repair for asphalt + concrete

## ► The #1 Rated Cold-Mix Asphalt Repair Material in USA

**COLD PATCH EVALUATION**

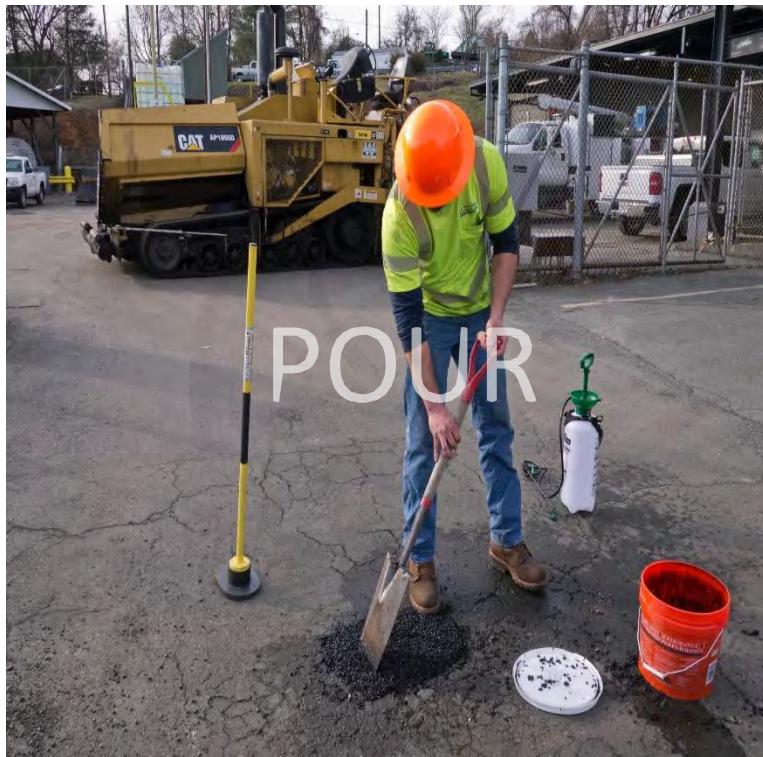
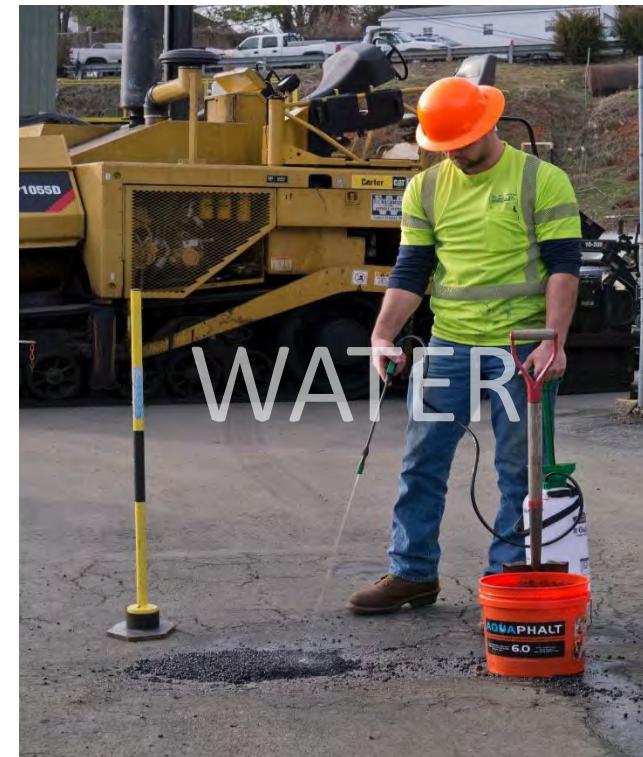
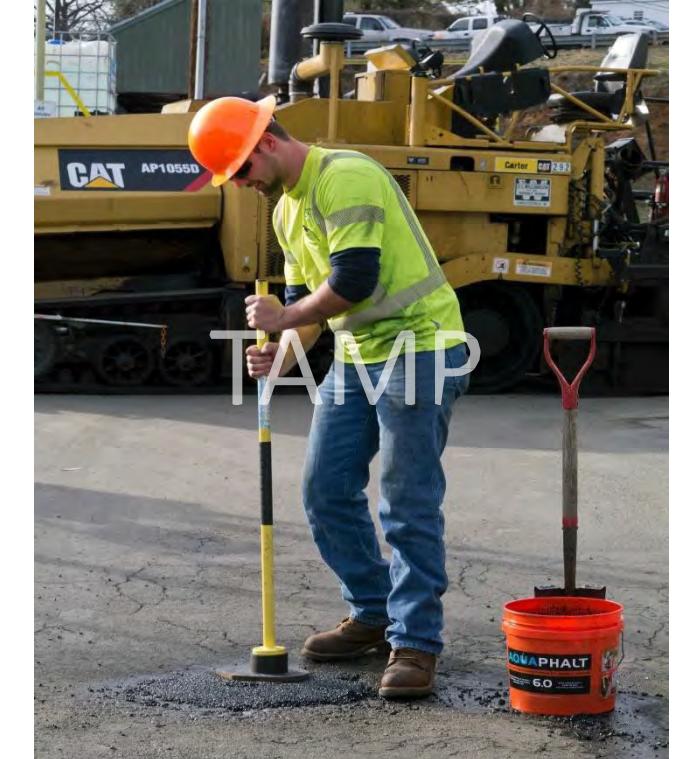
## 3-Step Installation

- **Installation** Remove all debris inside damaged area (with broom or compressed air), pour in Aquaphalt, level off with a rake or trowel, add salt/potable water, compact with a hand tamper, roller or vibratory plate compactor.

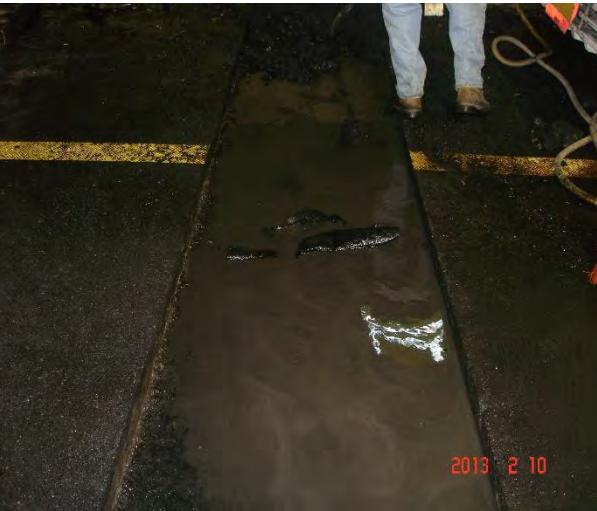
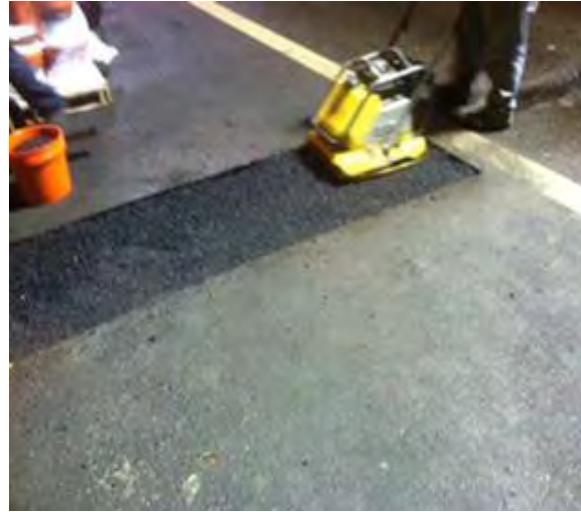
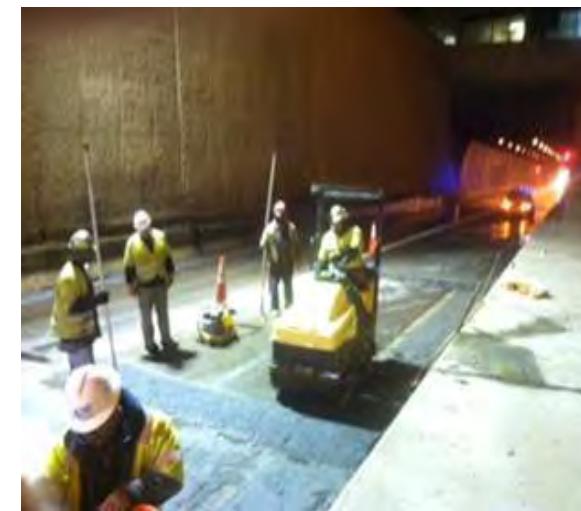
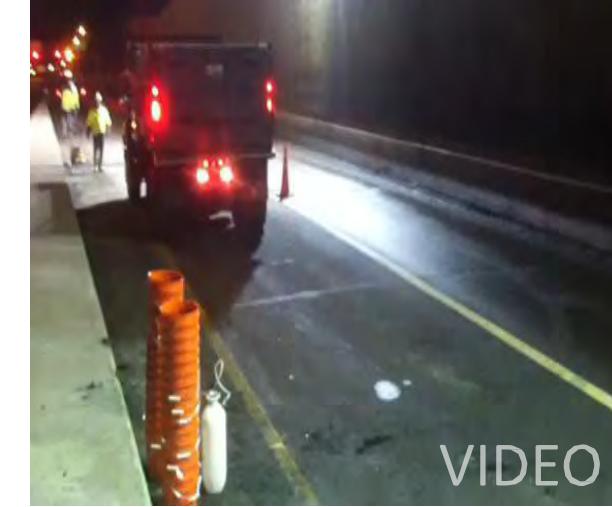
# Monitor-Merrimac Bridge Tunnel

27' below sea level with  
water seeping in.

Aquaphalt was placed,  
watered, and compacted.

Final compaction with a roller.

Open to traffic immediately  
after compaction.

**"We repaired over 30 joints at the approaches of the MMBT in this manner. Regular hot mix would not have done the job in these wet and dirty conditions. These patches have been in place for over two years and have made me a believer."**  
- Mark Range, Virginia Paving Company, (division of Lane Construction)

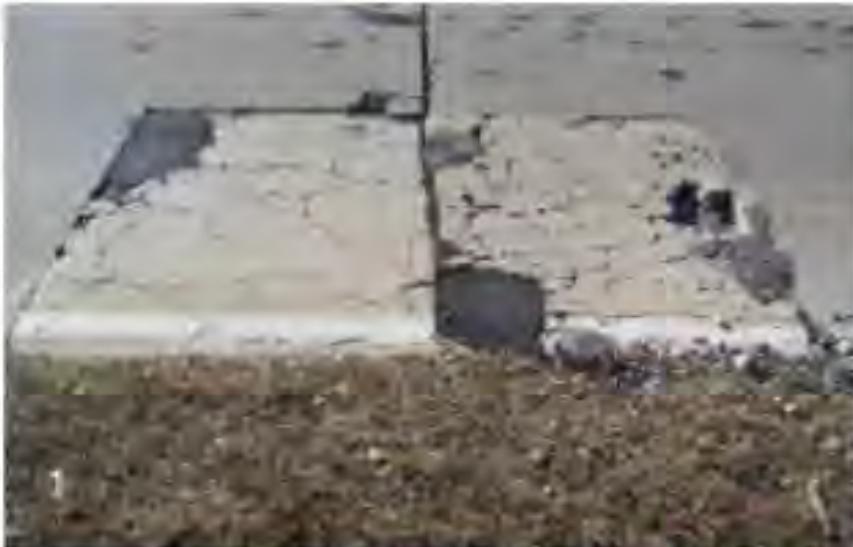
Figure 1, Evaluation site on US Route 60 West at Bottoms Bridge.

A deteriorated patch on US 60 West in New Kent County at Bottoms Bridge was selected for the evaluation site. This site would typically be repaired with hot mix asphalt (HMA), however the site was rapidly deteriorating and no HMA facilities were operational, therefore a 'permanent' cold patch solution was required.

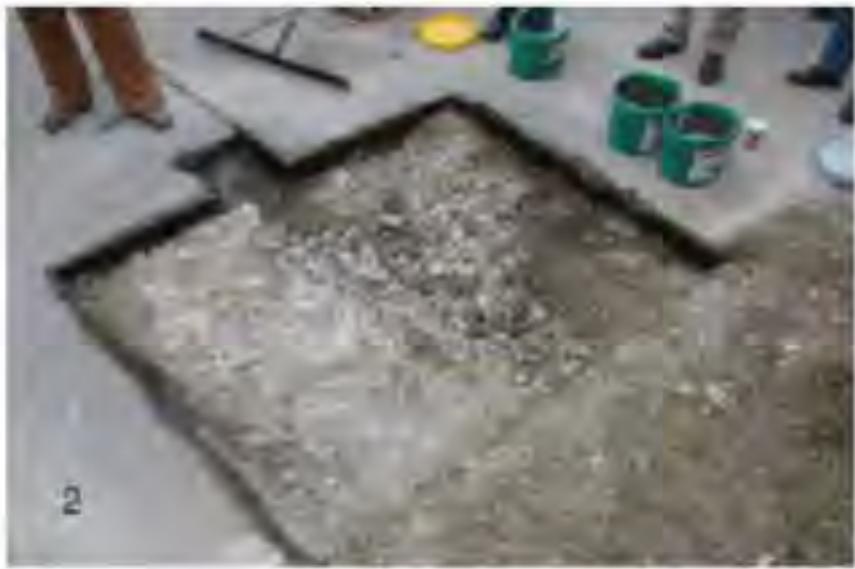
Figure 2

The existing distressed material was removed down to sound concrete. The leading half of the patch was found to be sound at a depth of approximately 5 to 6 inches (127 to 152.4 mm). The trailing half of the patch was deteriorated down to the subgrade in the center of the patch. The excavated patch was cleaned and blown free of loose debris, the deepest distressed portion was seated with a vibratory plate compactor.

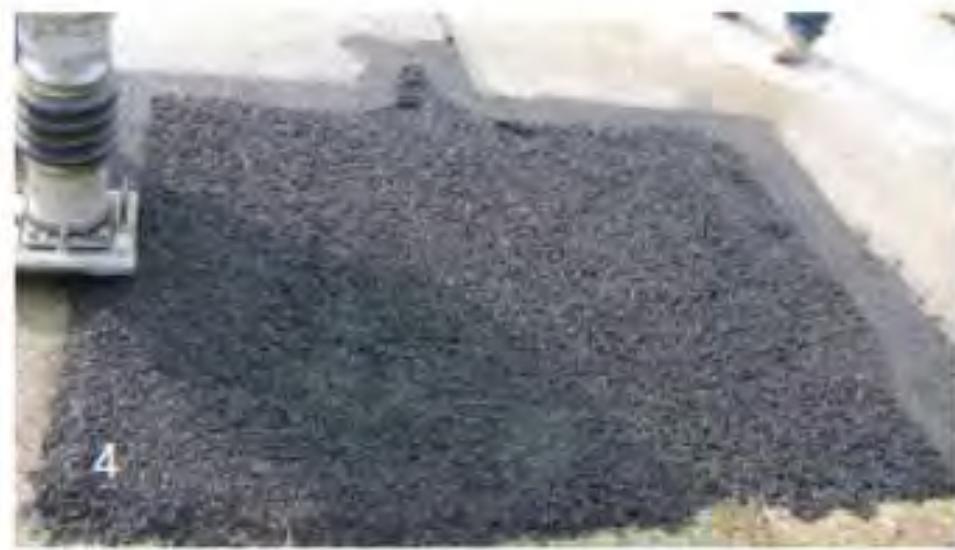
Figure 3. Two lifts 0/11mm mix were used as base and binder layers. The 'jumping jack' compactor was used for compaction on all layers lower than the final surface. Approximately 1 liter of water was added to each 25kg bucket before placement and an additional liter was "sprinkled" on the loose material before compaction.

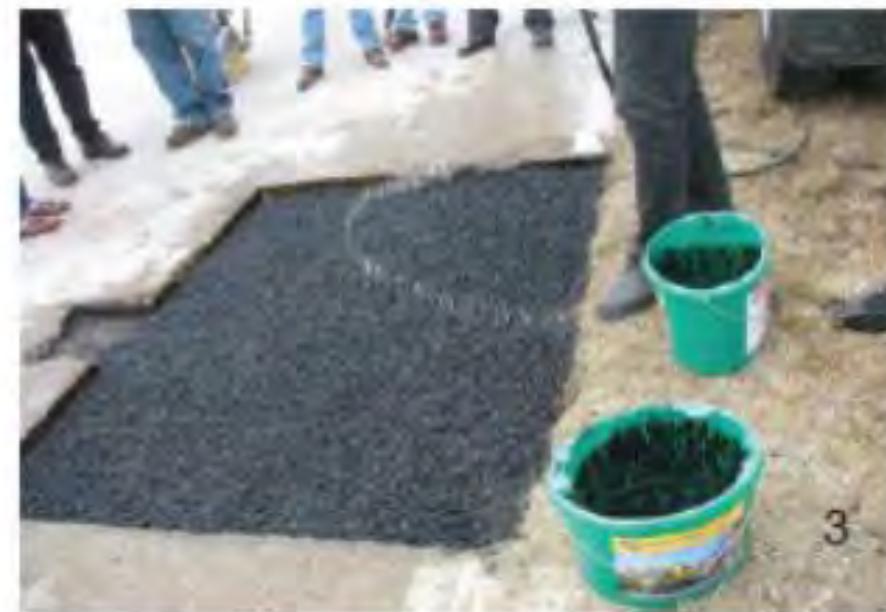
Figure 4. A final 0/8mm lift was placed for the final riding surface of the patch. Edges were pinched with the 'jumping jack' compactor.

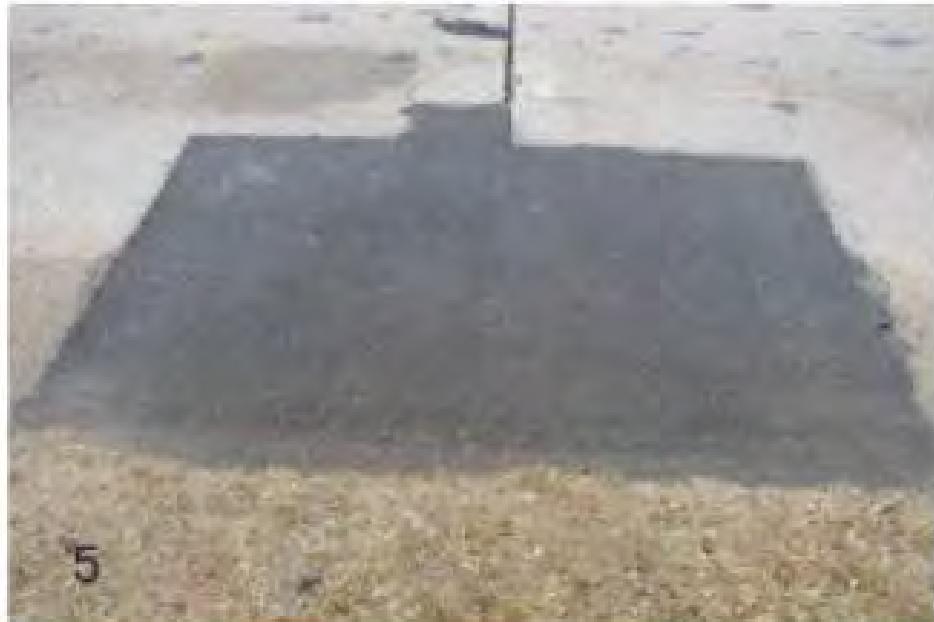
Figure 5, Evaluation site after one week of service.

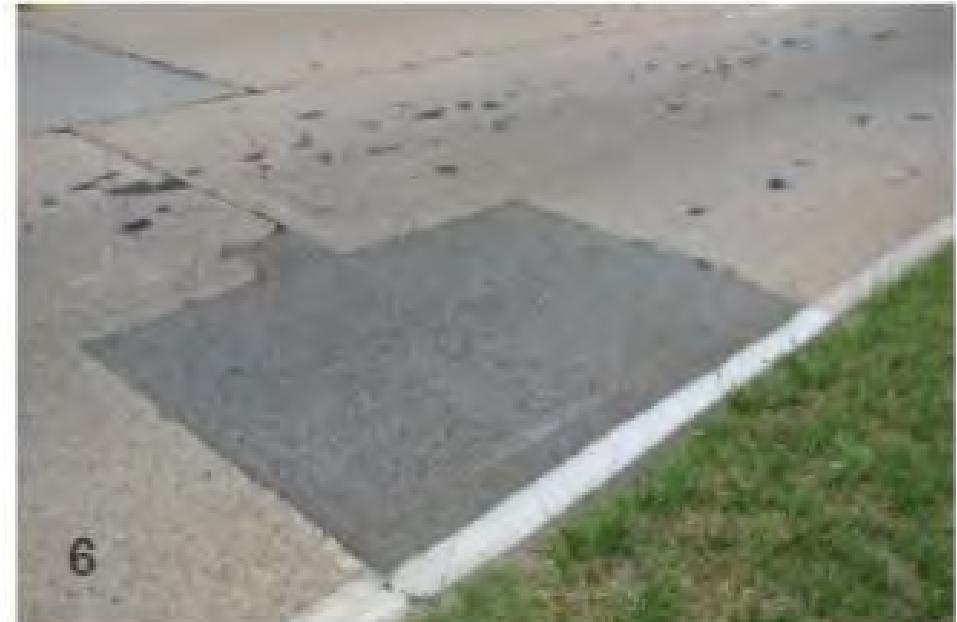
Figure 6, Evaluation site as of 06/26/08.

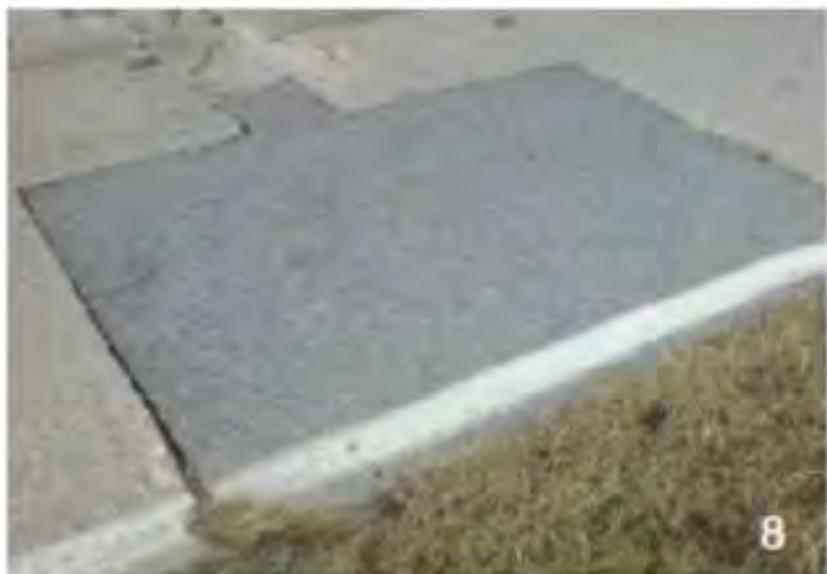
**Figure 7.** Material has maintained a uniform profile, very little to no pushing or shoving and no rutting. Tight joints have been maintained, material has not bled, or streaked away from the patch.

Five primary distress types were evaluated in the 1997 VTRC report used to generate VDOT's existing approved list: bleeding, rutting / dishing (further compaction under traffic), debonding, raveling and pushing & shoving. The Rephalt material did not exhibit any quantifiable distress in these five categories. To date the Rephalt cold mix material has met all expectations that the Virginia Department of Transportation has on cold mix patching materials.

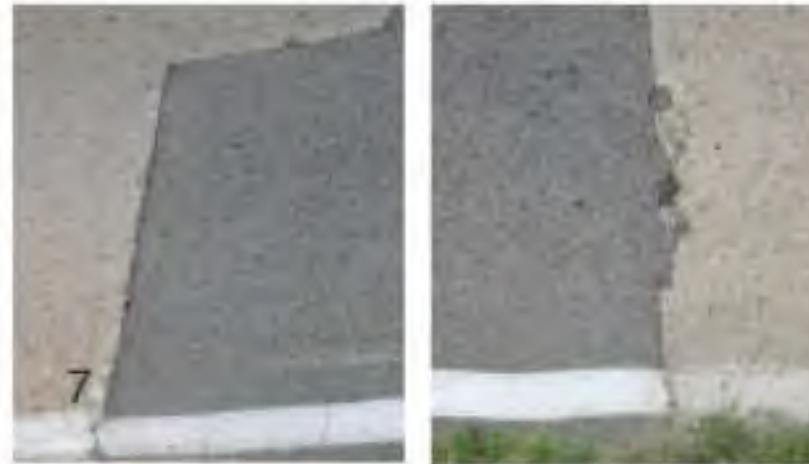
Figure 8, Four year follow-up photo, January 2012

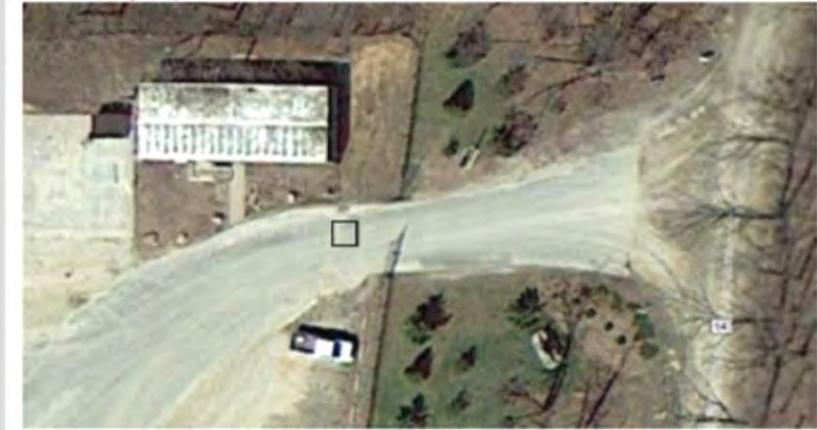
Figure 1. Site Map with rectangle showing dished area.

On Friday, 2/7/2014, a site needing repair was chosen that is located at the gated entrance to Rockydale Quarry. This location was selected for a field evaluation using both cold patch products to repair a dished area (1.5 to 1.75 inches in depth) at the entrance (Refer to sketch). Note that location is such that the wheel track on the passenger side of unloaded tandem axle trucks entering the facility would traverse both products (the Seaboard Patch first followed by the Aquaphalt patch) and loaded tandem axle trucks leaving the quarry loaded with crushed rock would have the driver side wheels traverse both products (first the Aquaphalt, then the Seaboard Asphalt).

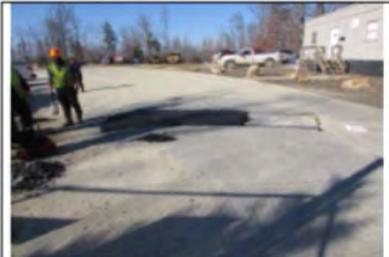
Figure 2. Hot Mix on left, chiseled area  
Cold patch evaluation

The edges of the dished area were chiseled to form more vertical edges, with loose material removed to a sound stable base. The area was wetted and broomed to remove standing water.

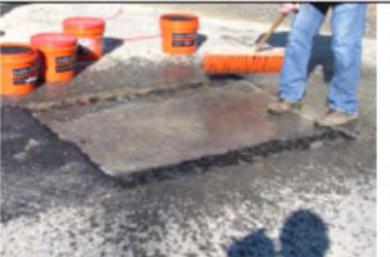
Figure 3. Area cleaned, wetted, & broomed  
near side Bond-X, far side Aquaphalt

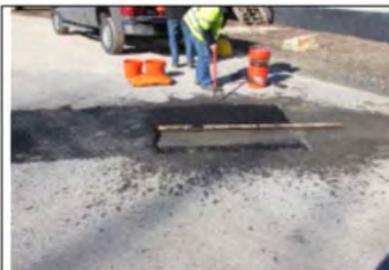
Figure 4. Aquaphalt spread & raked

Aquaphalt was spread and raked to same level towards the inside portion of the quarry with Bond-X raked and spread on the entrance side of the quarry. The finer Aquaphalt was slightly easier to rake and spread than the coarser Bond-X material, but both materials are deemed similar in workability.

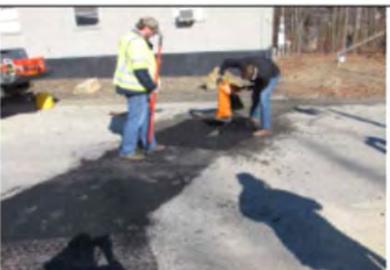
Figure 5. Bond-X spread & raked

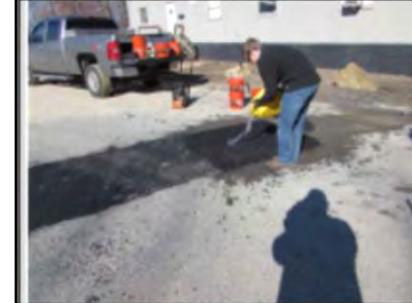
Figure 6. Both wetted 2 gallons water

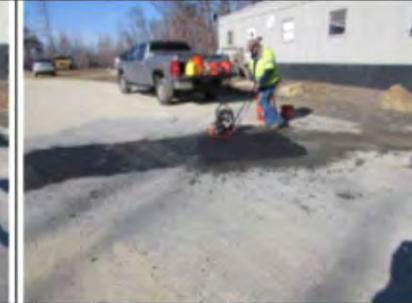
Figure 7. Both Compacted with Flat Plate

After both areas were shoveled, raked to crown and compacted with same number of passes using a Makita flat plate compactor. Temperature during placement varied from 38°F to 40°F. After compaction, the Bond-X had 99 pcf wet density with 37% voids, had a coarser surface texture and had more sheen. The Aquaphalt had 104 pcf wet density with 34% voids and had a finer surface texture with less sheen. At this time a loaded tandem axle truck left the quarry with a 5/16" rut measured in both the Aquaphalt (quarry side) and Bond-X (gate side) of the patch. Both materials have similar stability.

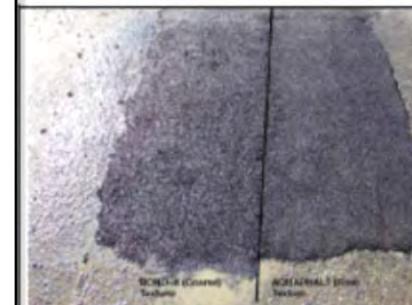
Figure 8. Surface Texture and Color

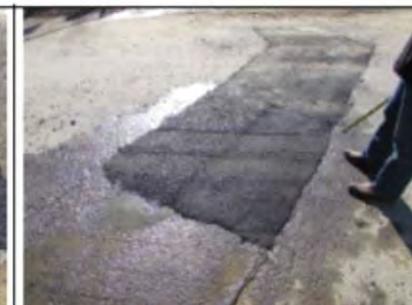
Figure 9. Loaded Tandem Axle Truck Rut

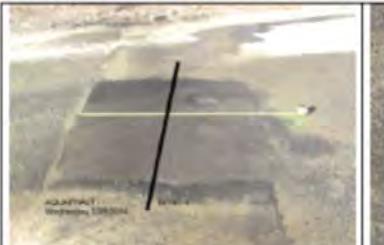
the cold patch. The Bond-X side had one depression where patch material had been removed approximately 1.25 inches to the original dished pavement and a second area where a depression had started (durability and resistance to water action issues)..

Figure 10. Patch loss of material      Figure 11. Close-up of Bond-X Patch

The Bond-X patch, probably due to overnight freeze and thaw cycles where water has frozen, is beginning to delaminate (see Figure 11) from the existing pavement.

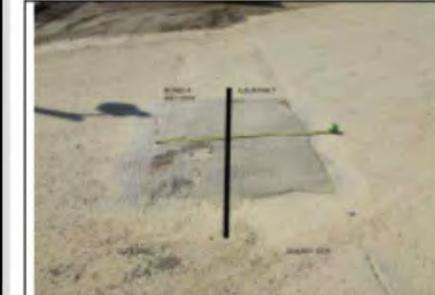
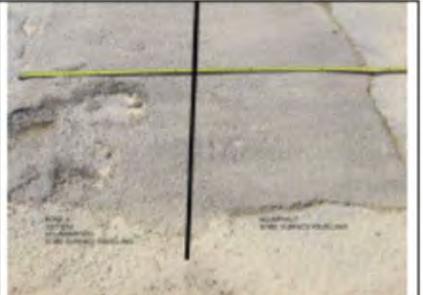
Figure 12. Both patches 3/21/2014      Figure 13. Bond-X delamination close up

The second visit to evaluate the performance after installation was on Friday, 21 March 2014, 23 days after installation of the cold patches. Temperatures ranged from an overnight low of 1°F to a daily high of 75°F with 4 days of snow and four days of rain. The Bond-X side had one depression where patch material had enlarged from the first visit to a depth of about 1.25 inches to expose the original dished pavement. The delamination had started to connect to the earlier second depression observed starting on the first visit. Both cold patches had some raveling on the surface where wheel path wear had removed some of the surface aggregate from the binder.

Based on the above information where both materials were placed under the same wet conditions, had similar compactive effort, with equal ESAL loadings, equal snow/rain events, and equal freeze thaw cycles, the field conditions demonstrate that the Bond-X material delaminated due to durability, stickiness and resistance to water action issues, whereas the Aquaphalt material did not.
